Product Safety Recall

N202322233 Seat Belt May Not Be Properly Attached

Release Date: January 2021

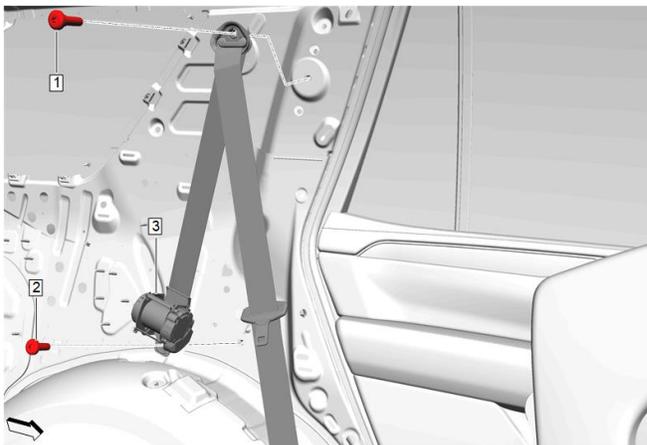
5607363

Second Row Retractor Mounting bolt (2)

3. Remove the second or third row seat belt retractor bolt as required. Discard the bolt.
4. Install the new retractor mounting bolt. Refer to the note above for installation details. Tighten the new service bolt to 45 N.m (33 lb. ft).
5. Reinstall the quarter lower rear trim panel. Refer to *Quarter Lower Rear Trim Panel Replacement* in SI.
6. Reinstall the rear compartment floor stowage compartment. Refer to *Rear Compartment Floor Stowage Trim Compartment Replacement* in SI.

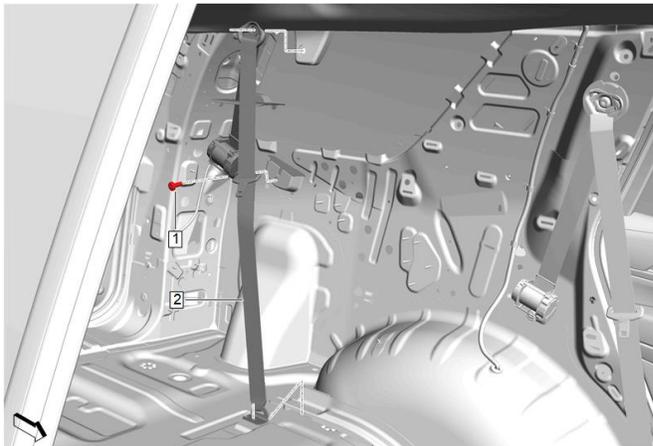
5634145

Third Row Retractor Mounting Bolt (1)
